Manhole Inspection Summary

Manhole # S09AA1016MH

Insp Date: **6/28/07 10:28 AM**

Location Address: **3800 EDGEWOOD AVE**

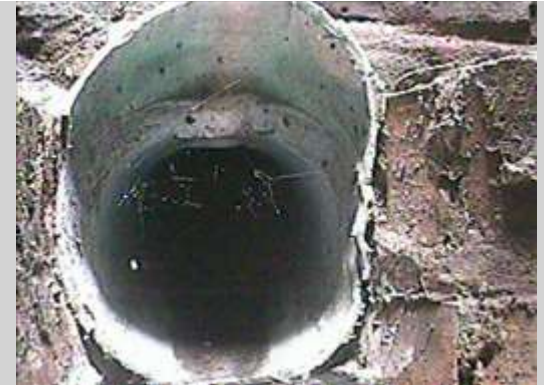
12 O'Clock Outflow

8 in. Circular Gravity Sewer
Pipe Out @ 12 O'Clock

Pipe Height: (in.) Direct
Pipe Material: **PVC** ☐ Pipe Lined
Invert Depth: **6.36** (ft.) Flow Characteristics: **Slow**
Deposits: ☒ None ☐ Mud ☐ Sludge ☐ Debris ☐ Grease
Silt Depth: (in.) Deposits Extent:
Infiltration: **None** Pipe Seal Cond: **Sound**

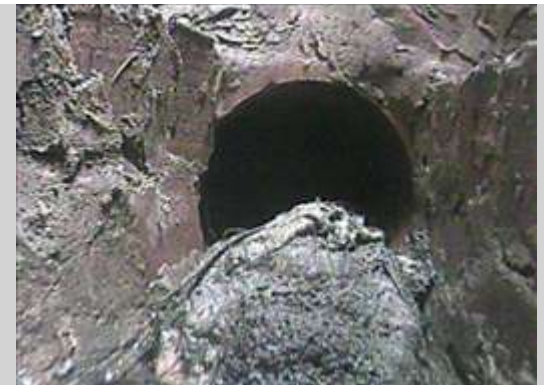
3 O'Clock Inflow

6 in. Circular Gravity Sewer
Pipe In @ 3 O'Clock

Pipe Height: (in.) Direct
Pipe Material: **Clay** ☐ Pipe Lined
Invert Depth: **6.20** (ft.) Flow Characteristics: **Slow**
Deposits: ☒ None ☐ Mud ☐ Sludge ☐ Debris ☐ Grease
Silt Depth: (in.) Deposits Extent:
Infiltration: **None** Pipe Seal Cond: **Cracked**
